- PRODUCT(S):** **SFP:** PIXMA iP3000/iP4000/iP5000/iP6000D/iP8500
 MFP: PIXMA MP750/MP760/MP780
- AFFECTED:** All Units
- DESCRIPTION:** ##359 (for MFP) / 13 Alternating Blinks (for SFP) Paper Feed Position Error
- SOLUTION(S):** Realign the Lift Cam Shaft Assembly

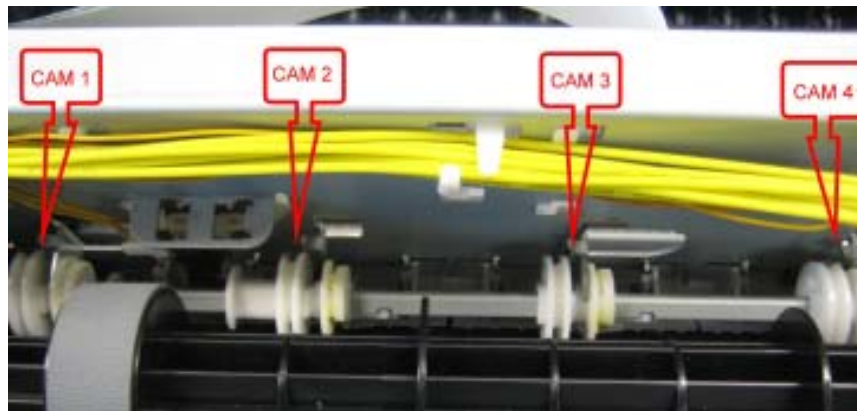
FIGURE 1 : LIFT CAM SHAFT ASSEMBLY

Sudden movement or impact (i.e. from shipping) may cause the Lift Cam Shaft Assembly to shift. When this occurs, the Cam Shaft slides inside the bracket to the right, which prevents the Cam Shaft from rotating properly. This will cause a ##359 (for MFP) / 13 Alternating Blinks (for SFP) Paper Feed Position Error.

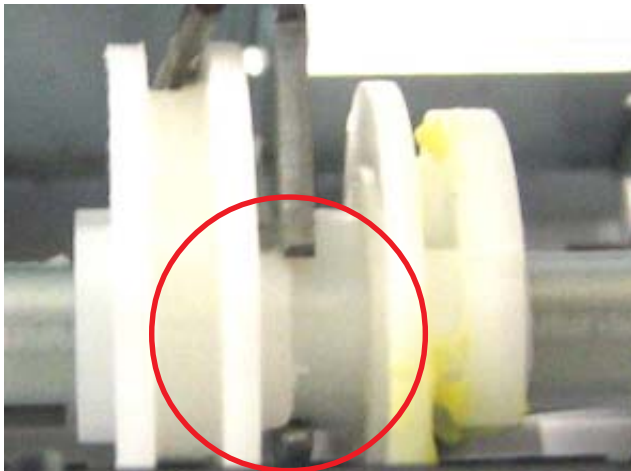
INCORRECT POSITION FOR THE LIFT CAM SHAFT ASS'Y

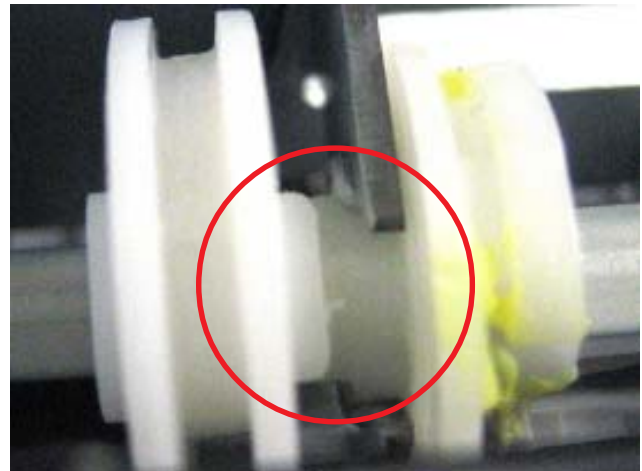
CORRECT POSITION FOR THE LIFT CAM SHAFT ASS'Y
