**SL10**

**Level 2.5**

**Repair Documentation**

V 1.3

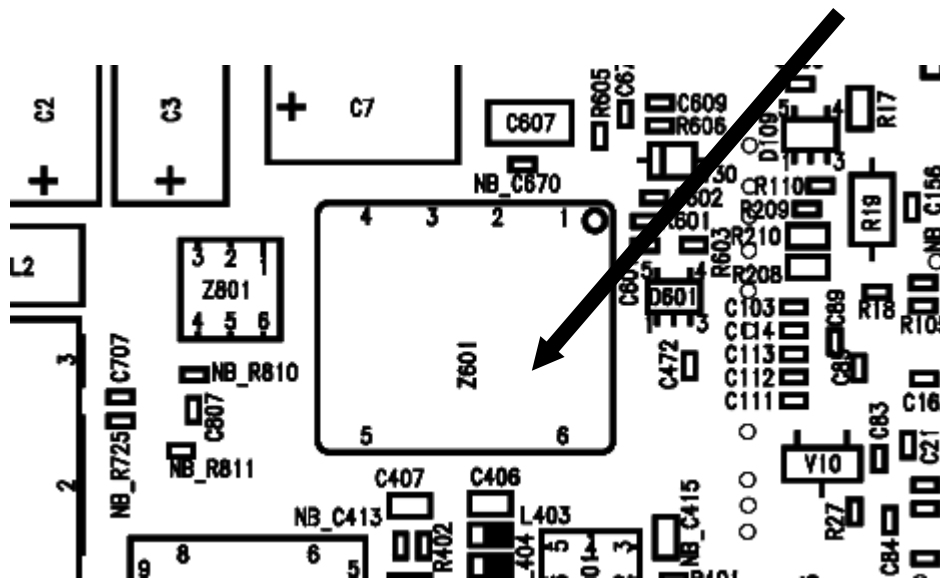
Figure 2: TCXO (Z601) Placement (Top View)

The TCXO (Temperature Compensated Crystal Oscillator) is responsible for generating the 13 MHz reference frequency of the handset.

If it is defective, the handset cannot synchronize to the base station anymore.

If the frequency error is higher than 2kHz, the TCXO has to be replaced.

Use hot air blower to remove defective TCXO.

Resolder new TCXO afterwards.

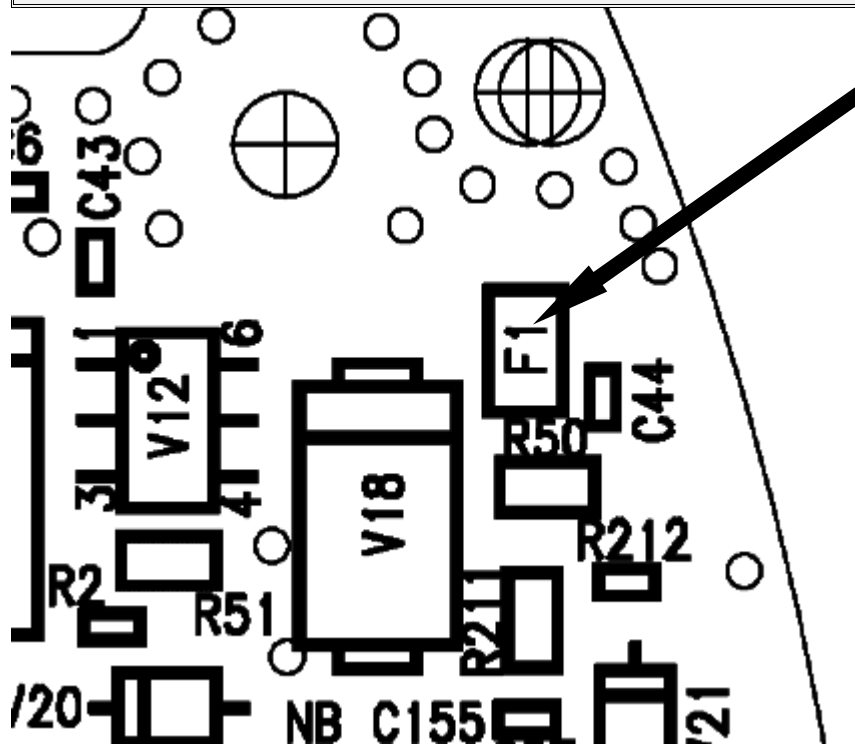
Figure 2: 1A Fuse (F1) Placement (Top View)

Battery charging not possible

Check the status of the fuse by measuring its resistance with a multimeter. The fuse is defective if the resistance is higher than 10 ohms.

Use soldering iron to remove defective fuse.  
Avoid excessive heat!  
Watch surrounding components!

Resolder new fuse afterwards.

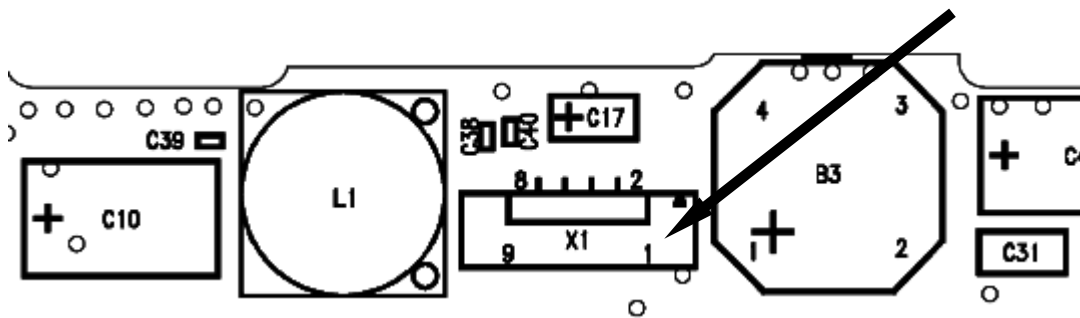
Figure 2: Connector X1 Placement (Top View)

Problems with main keyboard. Either keys or the keyboard illumination not working properly.

Visually check the connector. Watch for dry joints.

Resolder dry soldering joints.  
If the connector is physically damaged use hot air blower or wick to remove defective connector.  
Avoid excessive heat!  
Watch surrounding components!

Resolder new connector afterwards.

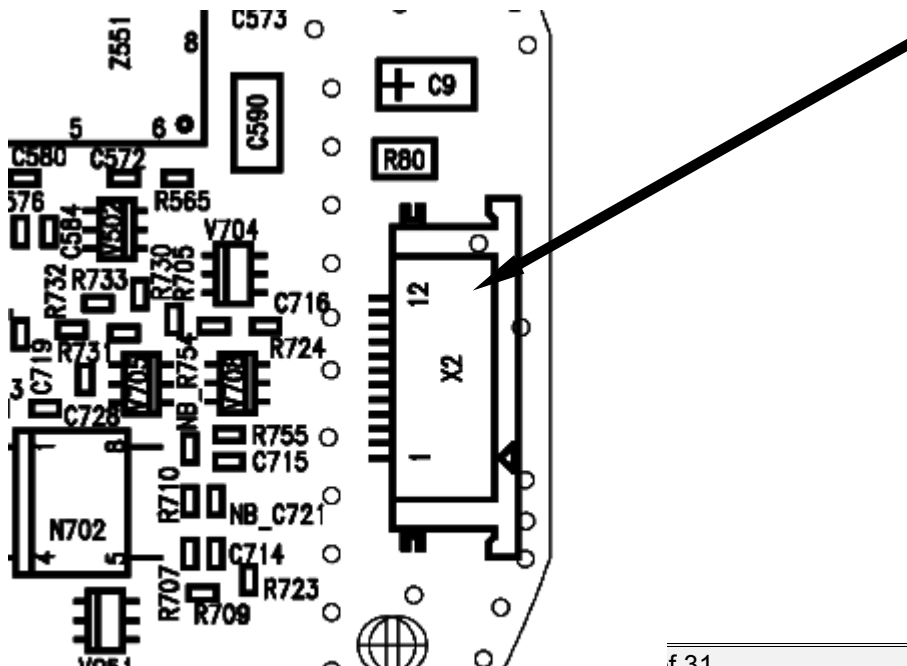
Figure 2: MMI Connector (X2) Placement (Top View)

Slider keypad does not work properly.  
Display problems.  
Display or keyboard illumination problems.

Visually check the connector. Watch for dry joints.  
Visually check the flexible cable coming from the upper MMI. Watch for dry joints on the MMI.

Resolder dry soldering joints.  
If the connector or flexible cable is physically damaged use hot air blower or wick to remove defective connector / cable.  
Avoid excessive heat!  
Watch surrounding components!

Resolder new connector/cable afterwards.

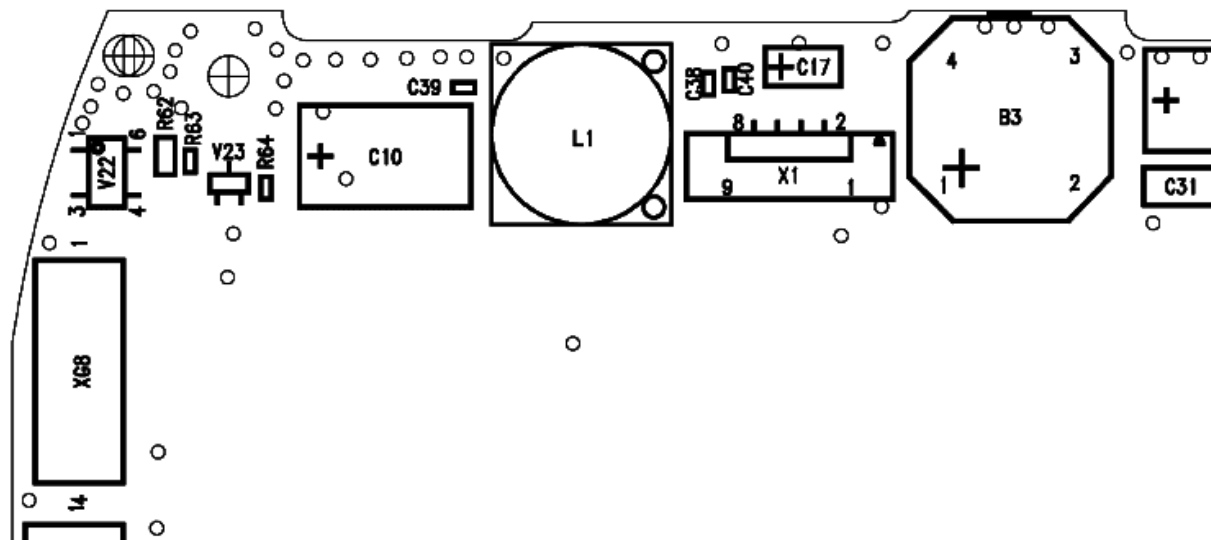
Figure 2: Ringer (B3) Placement (Top View)

No ringer tone audible or ringer tone distorted.

Use hot air blower remove defective ringer.  
Avoid excessive heat!  
Watch surrounding components!

Resolder new ringer afterwards.  
Watch placement of ringer hole!

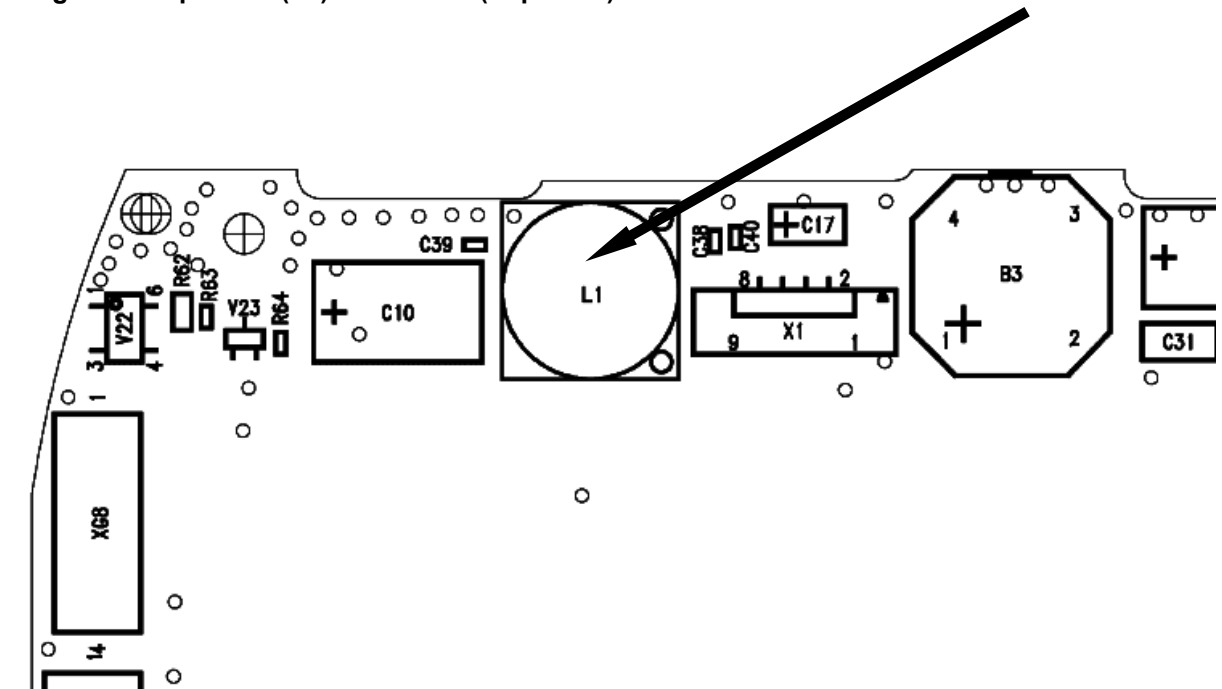
Figure 2: 31 $\mu$ H Coil (L1) Placement (Top View)

The 31 $\mu$ H coil is used in the step up converter which is generating a 6.0 V supply voltage for the power amplifier out of the 2.8V battery voltage.

If the coil is mechanically damaged (broken) it produces heavy interference with the acoustical elements of the SL10 resulting in a loud humming noise in the earpiece.

A broken coil can easily be diagnosed by trying to move it with two fingers. If it moves, the core is broken and the coil has to be replaced.

Use hot air to remove defective coil.  
Avoid excessive heat!  
Watch surrounding components!!

Resolder new coil afterwards

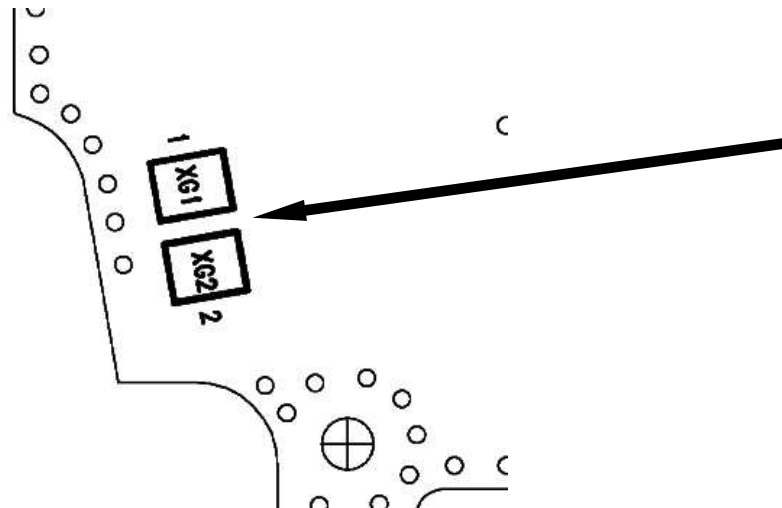
**Figure 2: Microphone Cable Soldering Pads (XG1;XG2)  
Placement (Top View)**

No microphone function.  
Other party cannot hear callers's voice.

Use hot air blower remove defective cable.  
Avoid excessive heat!  
Watch surrounding components!

Resolder new cable afterwards.
