# S6 GSM/PCN

## Level 2.5

# Repair Documentation

V1.4

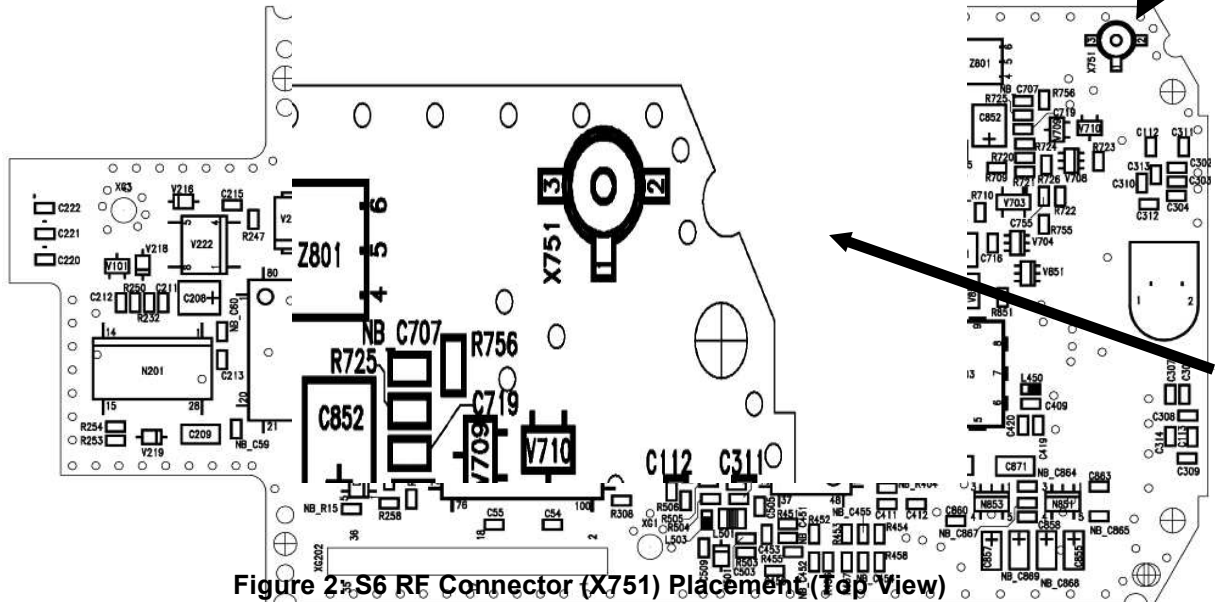
Figure 1: S6 Board RF Connector Side

Visually check the status of the antenna connector. Look for a bent contact or dry soldering joint.

Use hot air blower to remove defective connector.

Resolder new connector afterwards.  
Pin 1 is the RF pin, pins 2 and 3 are ground.

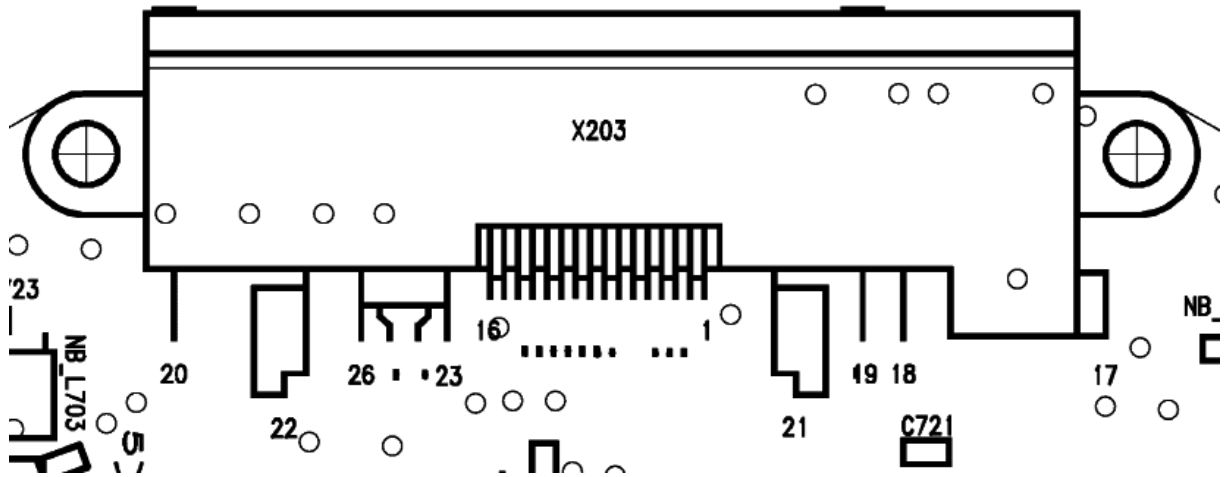
Figure 2: S6 External Connector (X203) Placement (Top View)

There is a mechanical switch in the bottom connector which switches between the external and internal antenna of the handset.

The switch is located behind pins 23, 24, 25 and 26, while 23 and 26 are ground connections and 24 and 25 are RF connections.

Dry joints at these pins will interrupt the RF connection both to the internal and external antenna of the handset, resulting in „network search“ problems.

See figure 2 for the location of the pins!

Fix new connector and solder ground connections first (Pins 18, 20, 21, 22, 23 and 26 in figure 2).

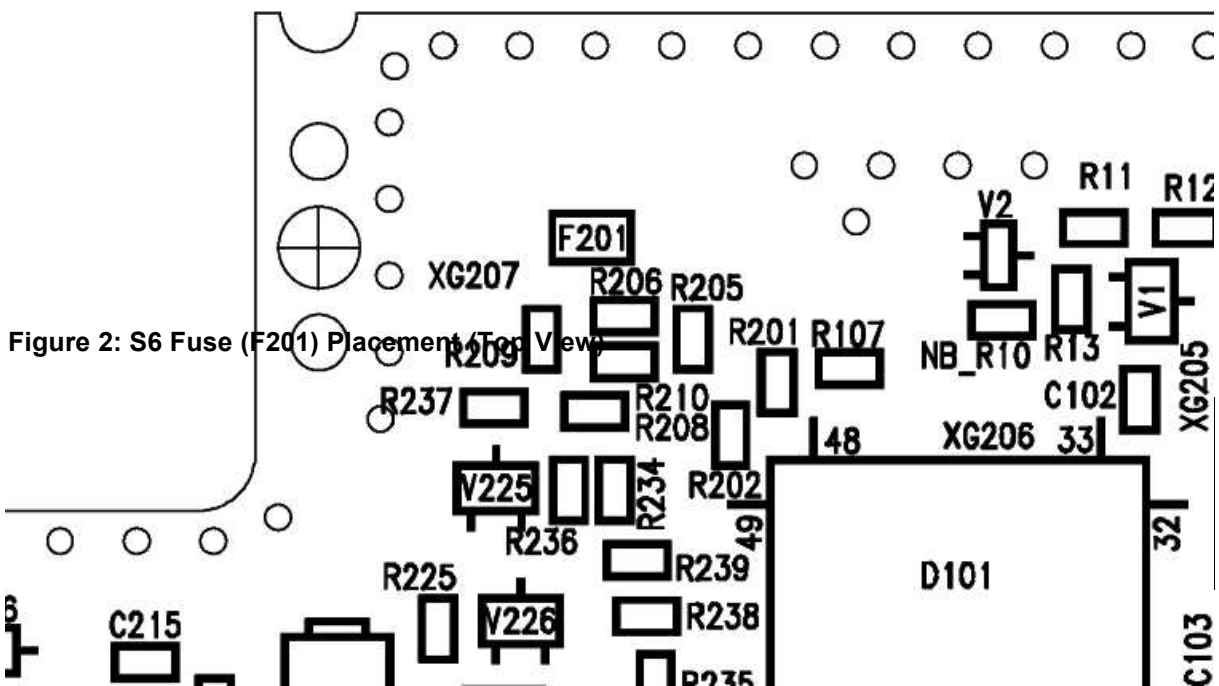
Figure 2: S6 Fuse (F201) Placement / Top View

If the customer connects a charger which delivers a current  $> 1$  ampere, the fuse F201 will blow to protect the charging curcuitry. The Siemens chargers have a current limit of 700mA.

The status of F201 can easily be checked with a multimeter. If the resistance is infinit, the fuse is blown.

Use soldering iron to remove defective fuse.

Resolder new fuse afterwards.

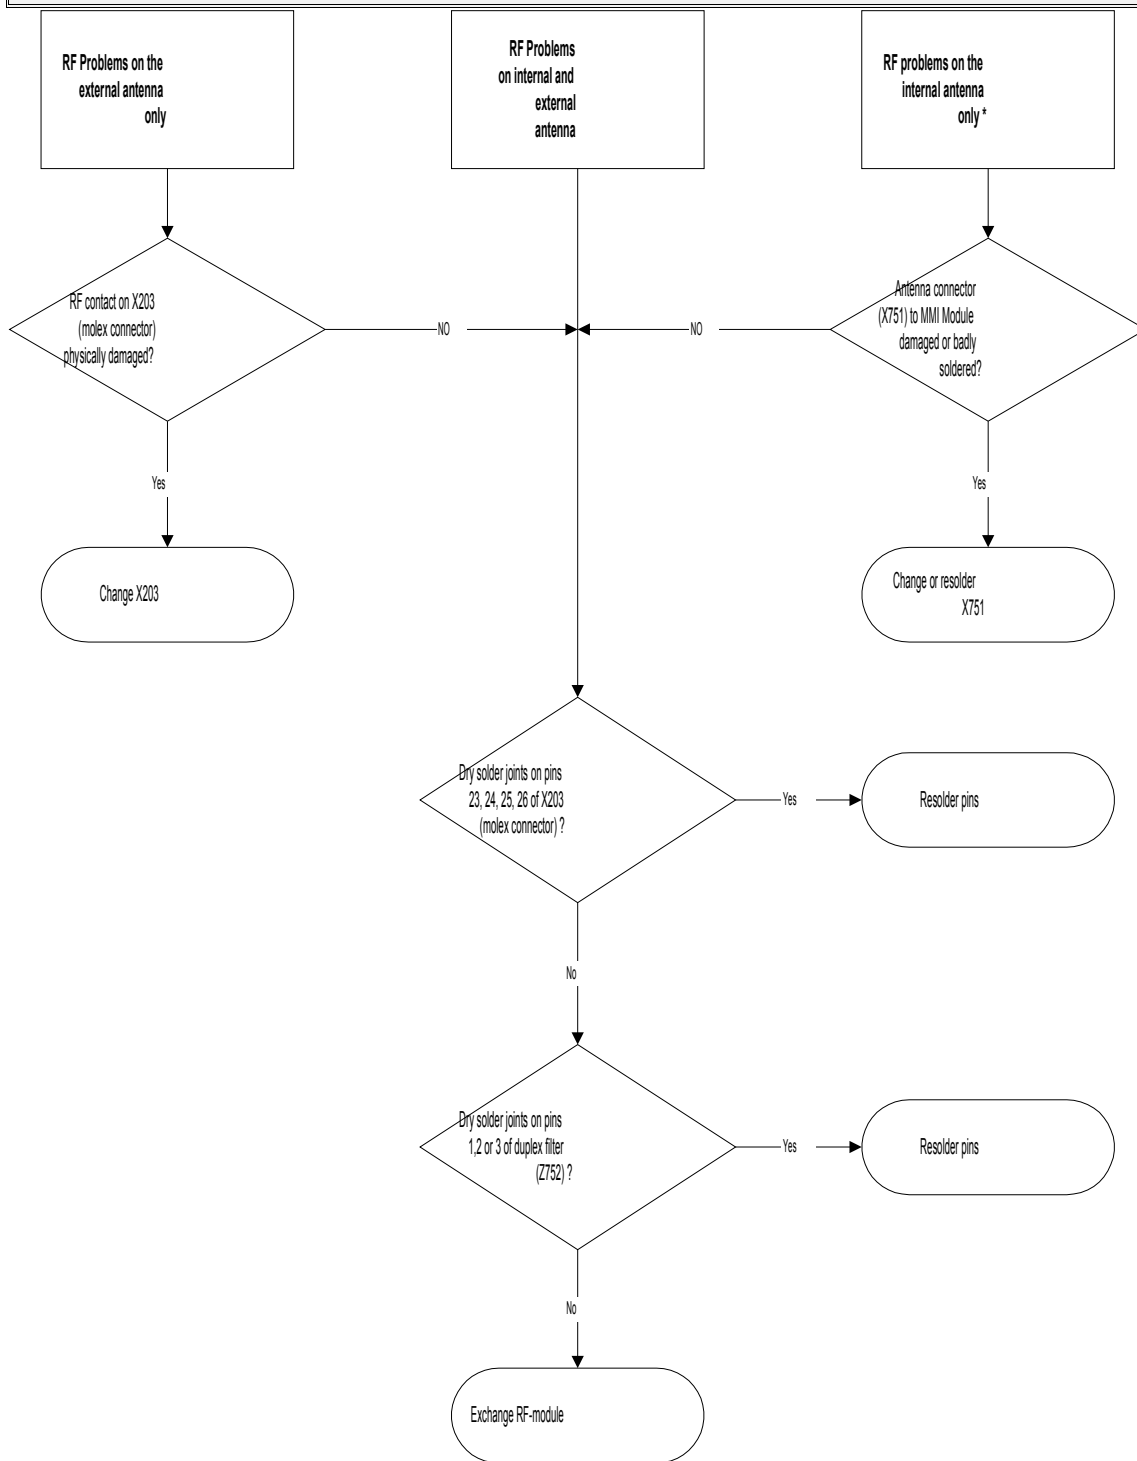
The S6 GSM/PCN, S6Classic GSM/PCN and the E10 have a mechanical antenna-switch in the bottom connector (molex connector).

As a consequence of this a lot of RF problems will come up, if the soldering is bad. Due to the difficult production soldering process of the bottom connectors, a relatively high percentage of handsets could be affected by this problem.

RF problems are for example a low or completely missing output power, or a missing RX-sensitivity.

In order to analyze the situation, please use the diagram below.

\* Internal antenna problems could also be caused by the display module. Make sure that you test the board with a reference display module.
