## RGB/Video Monitors Service Bulletin

**Model:** GVM-2020, GVM-2100

**No. 10**

**Subject:** Treatment for Horizontal Picture shaking

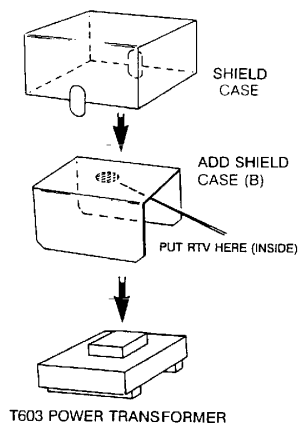
(137) Picture shakes horizontally

**Solution:** The Picture may shake left to right due to the magnetic flux leak from the power transformer and inrush current limiting resistor. Please take the following countermeasure:

**Addition of New Shield Case:**

1. Remove the current shield case from T-603 Power Transformer (F-Board).
2. Apply RTV (P/N: 7-322-065-19) to the inside of the NEW Shield Case (P/N: 4-041-545-01) as illustrated on the right.
3. Mount NEW Shield Case onto T-603.
