PHILIPS

OSC 60

OSCILLOSCOPE PM 3234

Already published: OSC 13 - OSC 26.
 Subject: Flash-over problem inside C.R.T.

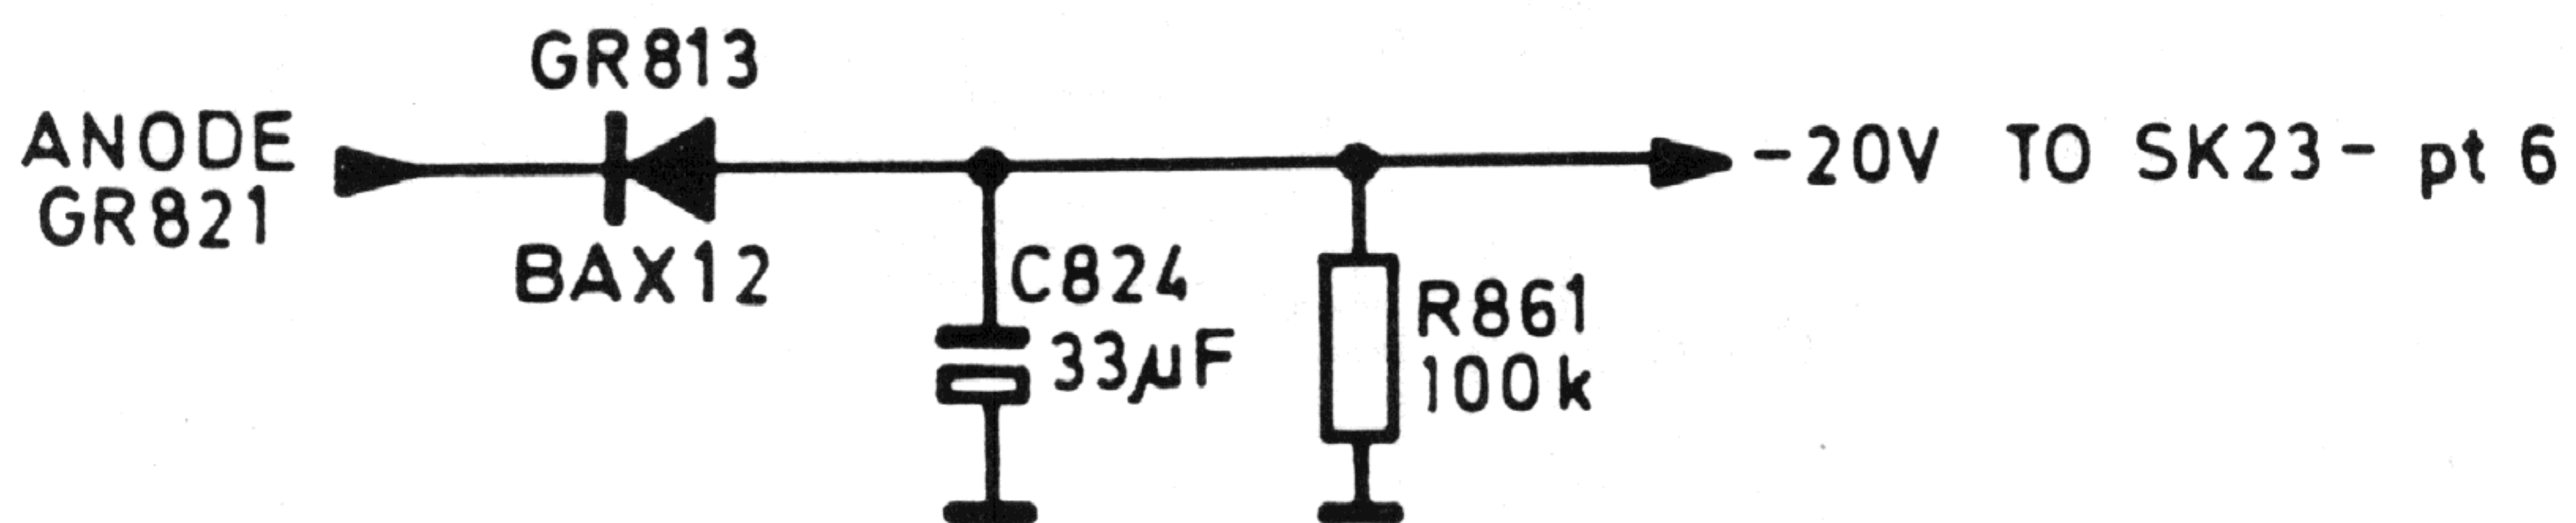
The print track between SK23 pt6 and R1043 on the storage unit is interrupted.

- During the production of the /12 version a modification is introduced to increase the memory off voltage from -30 V to -50 V , because of changed C.R.T. specification.
